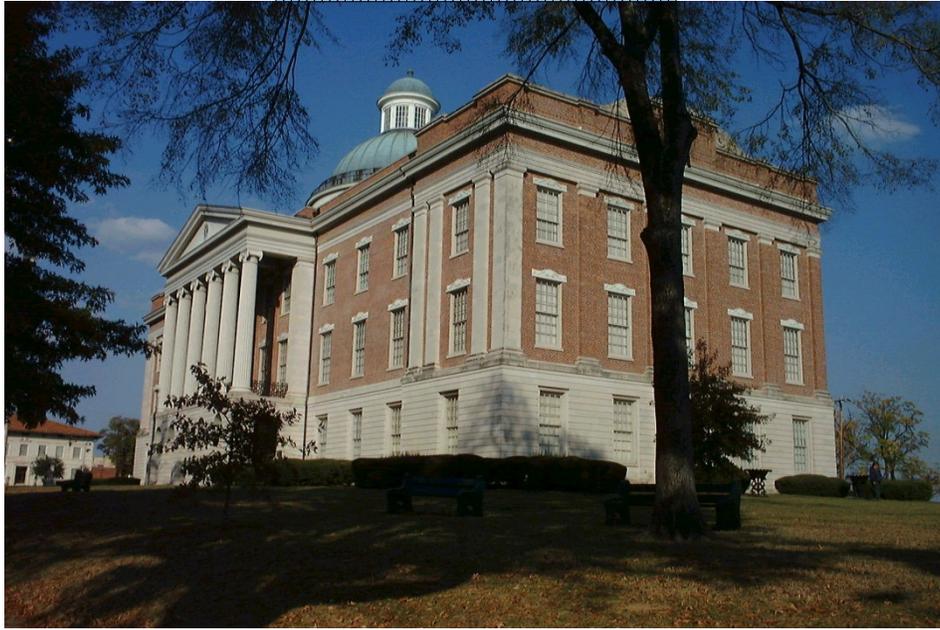
Fig. 1. Exterior Before replacing stucco

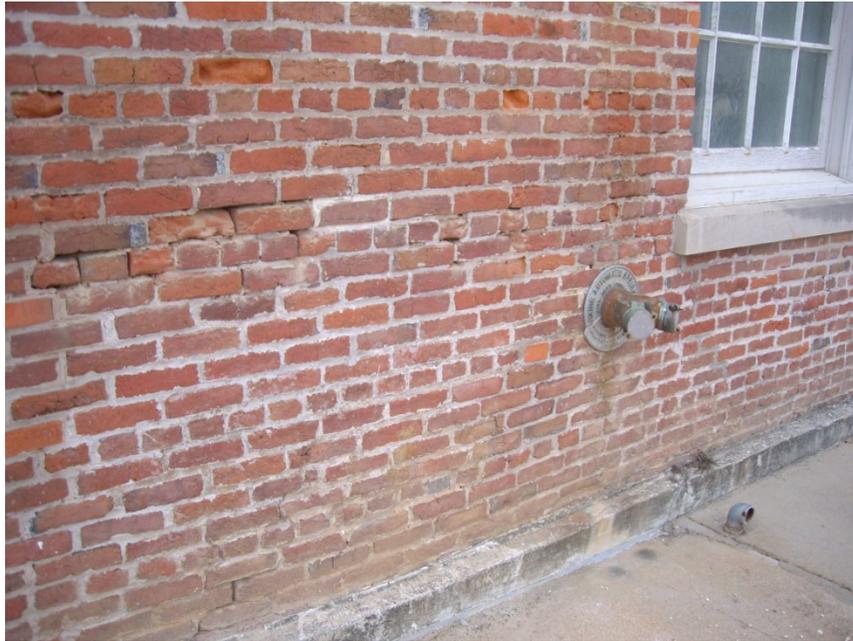
Fig. 5. East Elevation Deteriorated Brickwork

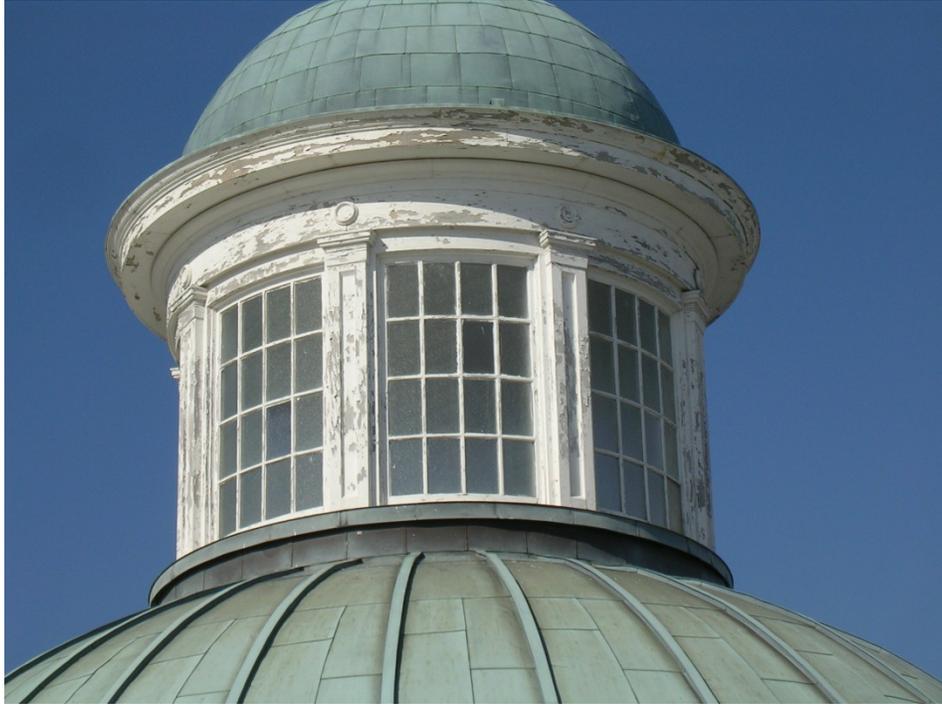
Fig.7. Cupola before Restoration

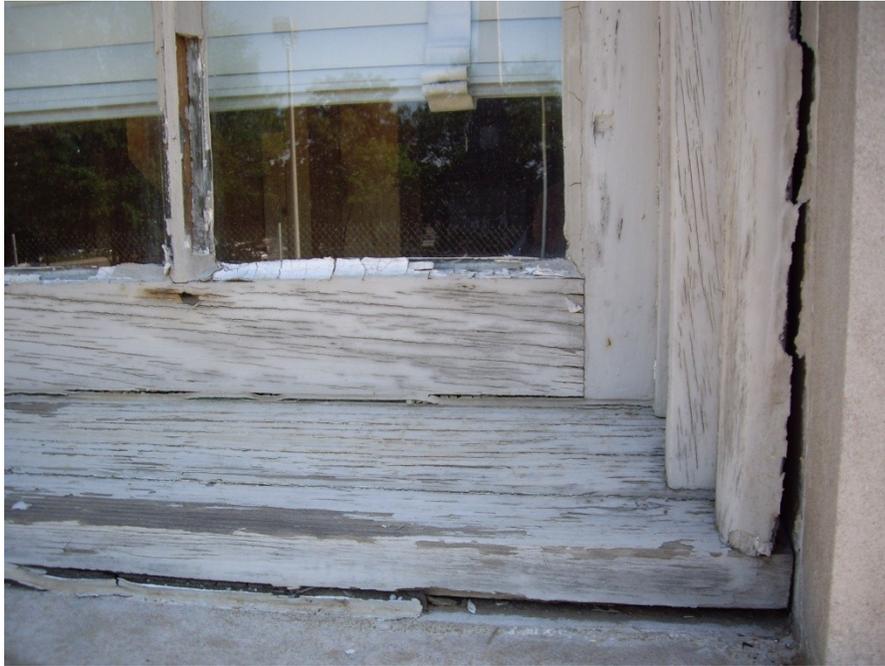
Fig. 9. Window Before Restoration

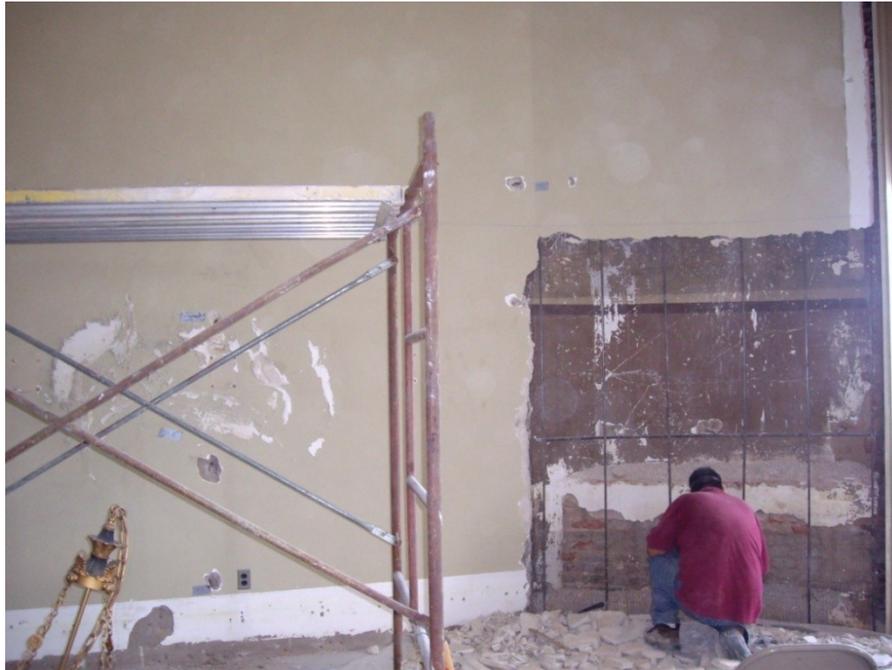
Fig. 11. Plaster Damage from Rising Damp

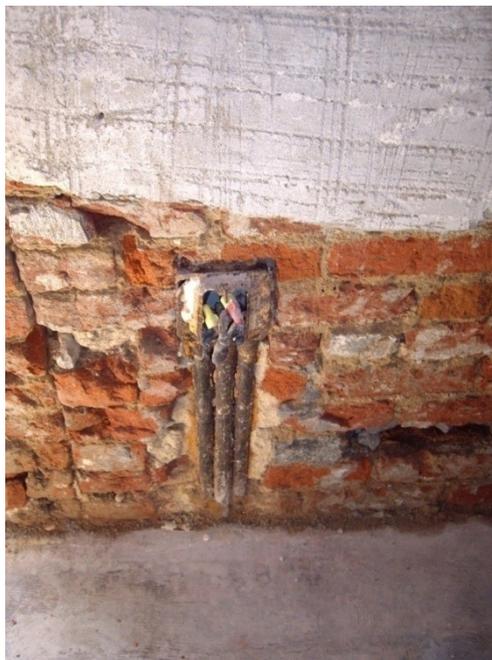
Fig. 12. Rusted Conduit, Soft Brick, under Partially Removed Coating

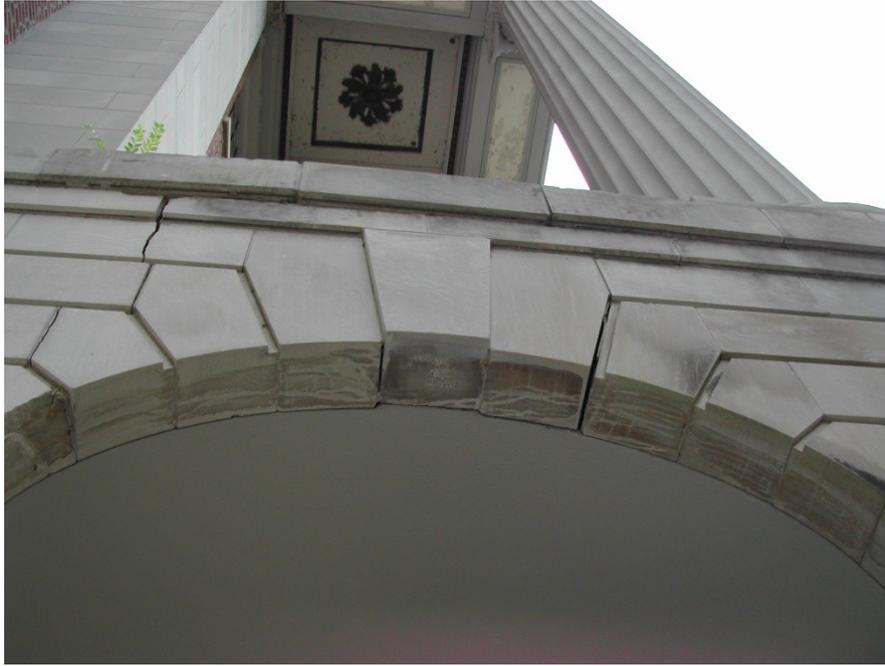
Fig. 39. Broken Limestone Prior to 2009 Restoration

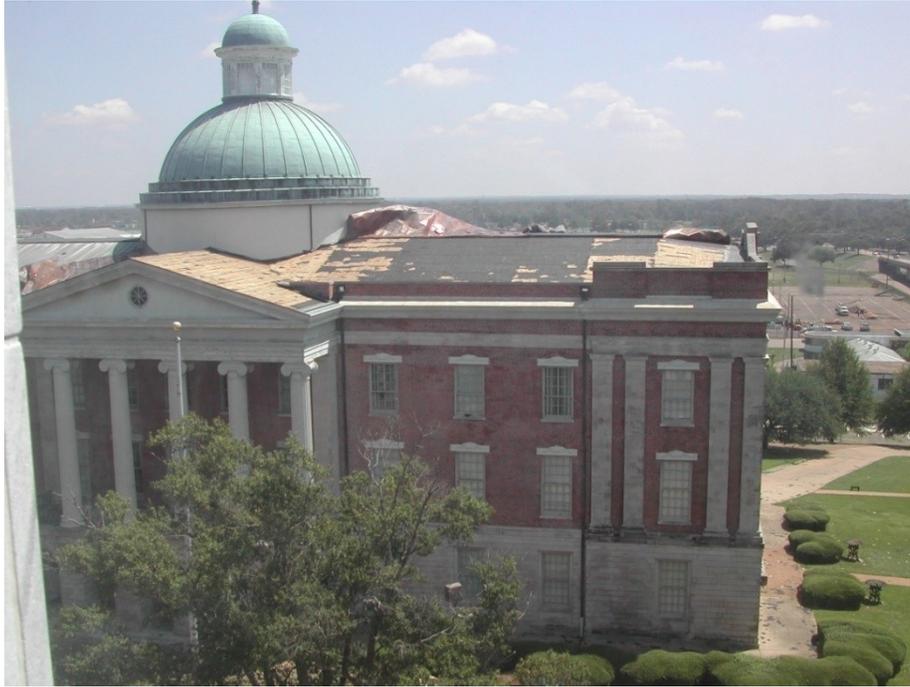
Fig. 41. Copper Roof Destroyed by Hurricane Katrina

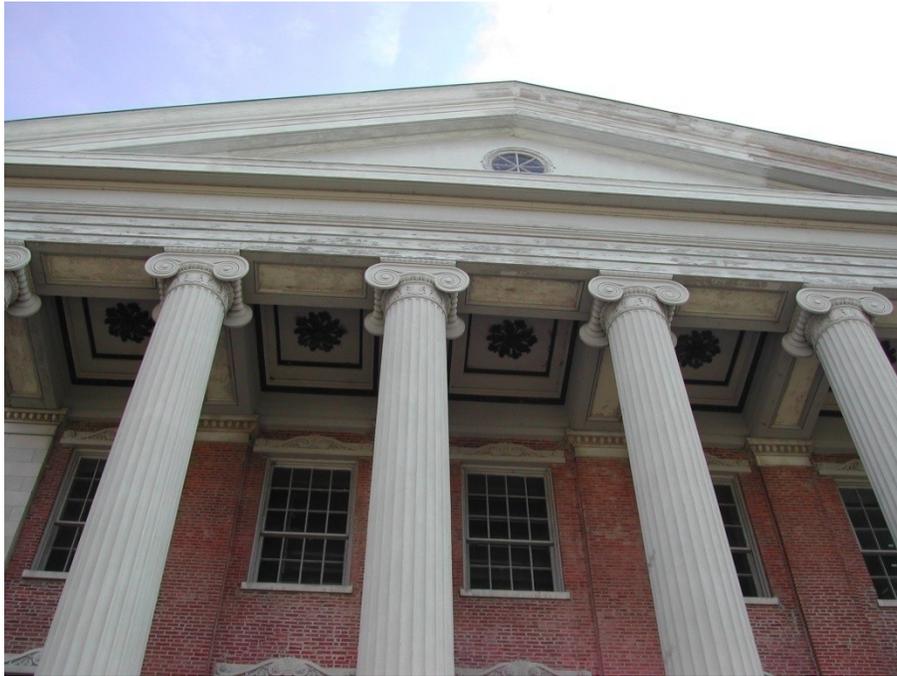
Fig. 43. Bulls eye Window in Portico before Restoration

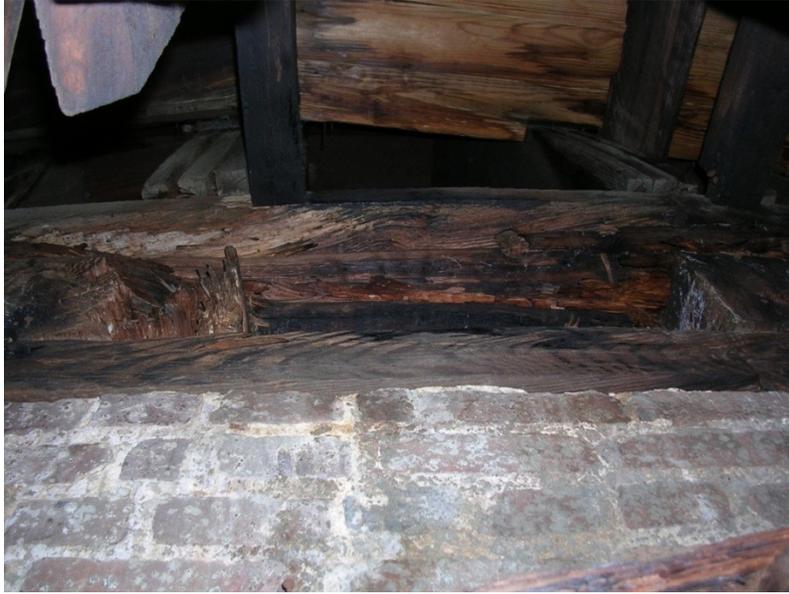
Fig. 51. Structure of Major Dome Showing Deterioration of Wood Members
