**2009 Restoration of the  
Mississippi Old Capitol Building**  
The Issues Addressed and the Decisions Rendered

Part 2  
Comprehensive Historical Report on the 2009 Restoration of the  
Old Mississippi State Capitol

Prepared by  
Robert Parker Adams, MAHP  
Architect for the Restoration

August 10, 2009

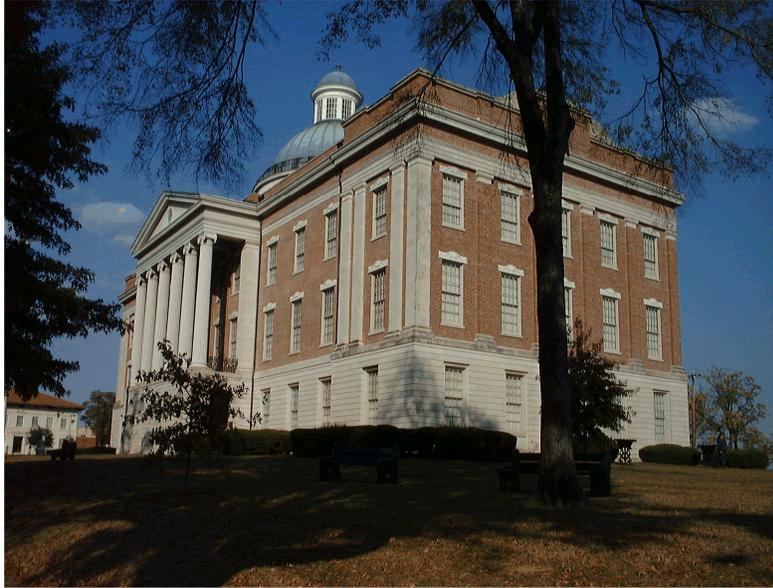
The original stucco existed on the building from 1839 to 1959 when it was removed during the restoration of that date, leaving the upper two floors with exposed brick. The exposed brick was in vogue in the mid twentieth century, so the stucco was not replaced. The upper two floors remained bare for the next fifty years and few people noticed the inconsistency between the rather sophisticated stonework and cornices and the crudity of the poor quality brick. Even fewer remembered the original appearance of the stucco.

The brick was poor in construction, inconsistent in porosity, and was never intended to be left unprotected. The result was moisture penetration through the fabric of the walls which degraded the brick and mortar and affected the interior plaster surfaces. The decision was made in 2008 to replace the stucco as originally designed by architect Nichols.

Fig.1. Exterior Before replacing stucco

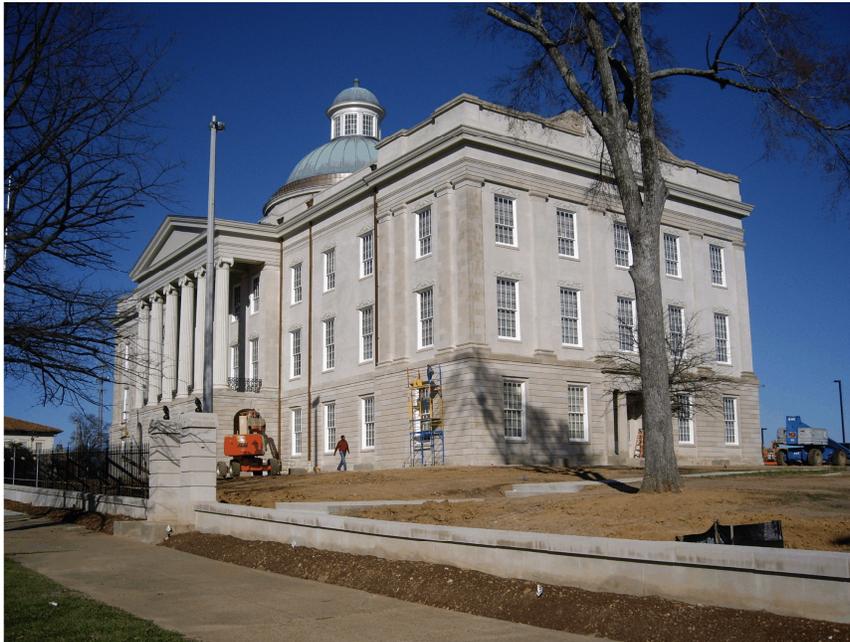
Fig. 1. Exterior  
After replacing

stucco
