Subject:
Drum Inventory
Former Vicksburg Chemical Company
Vicksburg, Mississippi

Date:
8 January 2007

Photographic Log

Mississippi Bluffs –
Drum Inventory

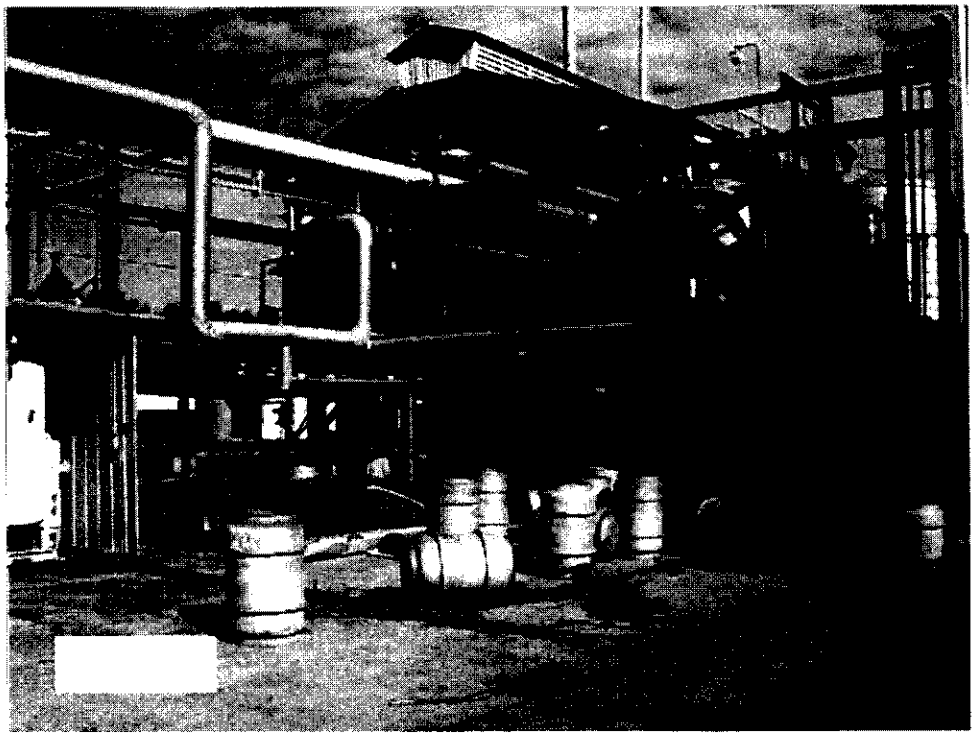
Photograph 1: Multicote Loading Rack – Drums – Looking North.

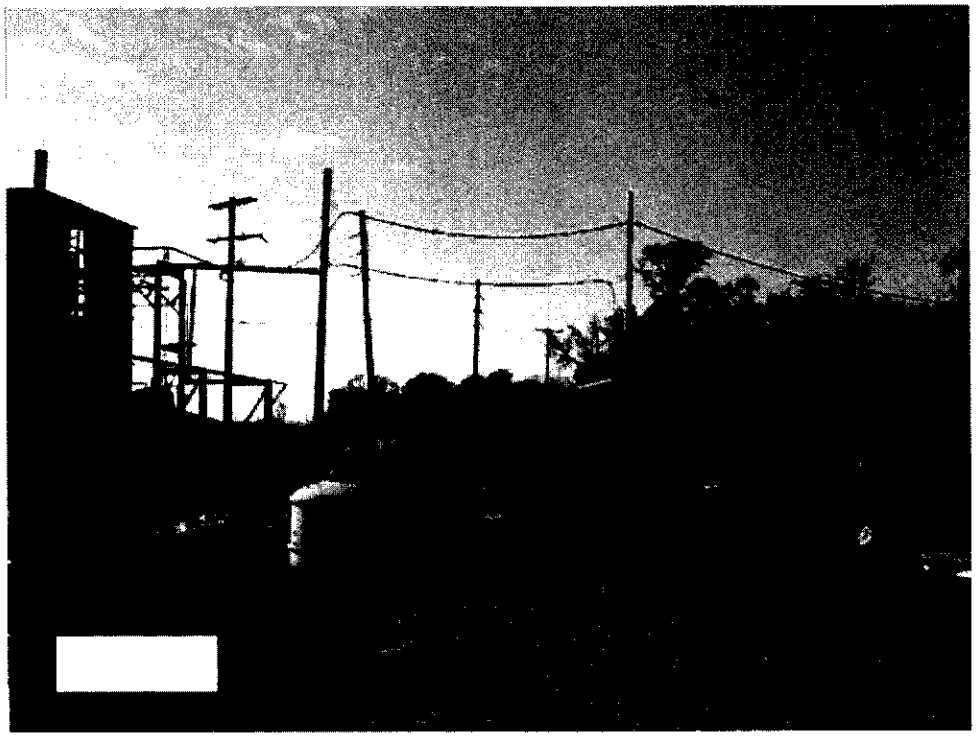
Photograph 7: Shop Laydown Yard – Looking South.

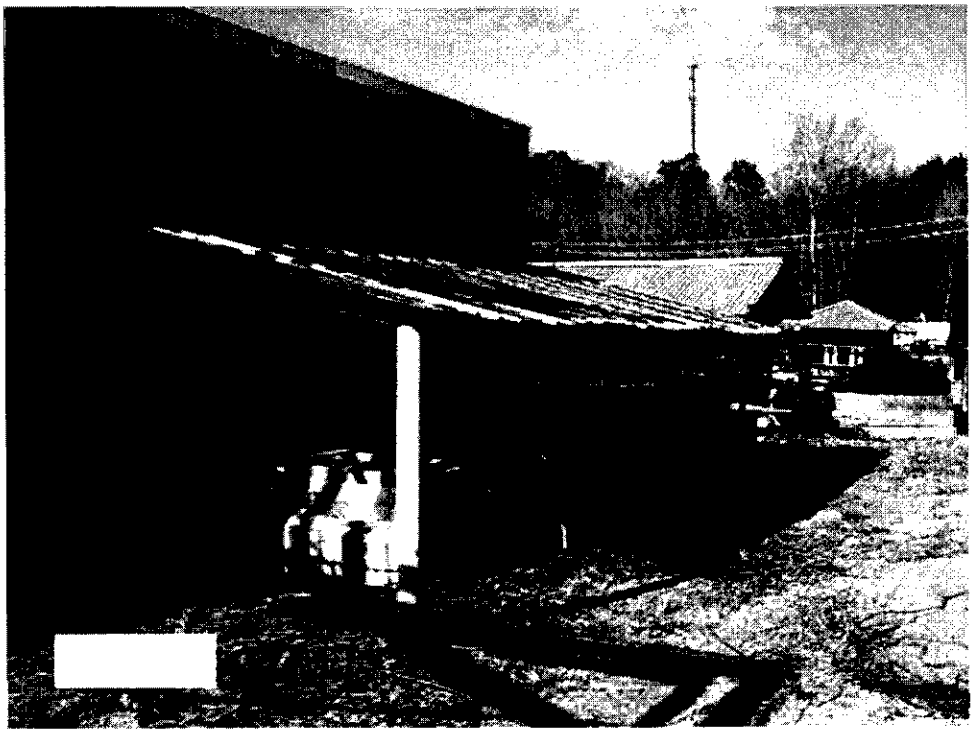
Photograph 8: Behind Laboratory – Carbon Drums– Looking West.
