**CONSTRUCTION STATUS REPORT  
CLOSURE/RETROFIT OF  
SURFACE IMPOUNDMENT SYSTEM  
CEDAR CHEMICAL CORPORATION  
VICKSBURG, MISSISSIPPI**

**CEDAR CHEMICAL CORPORATION  
VICKSBURG, MISSISSIPPI**

**IT CORPORATION  
8687 UNITED PLAZA BLVD., SUITE 103  
BATON ROUGE, LOUISIANA 70809**

**MAY 1992**

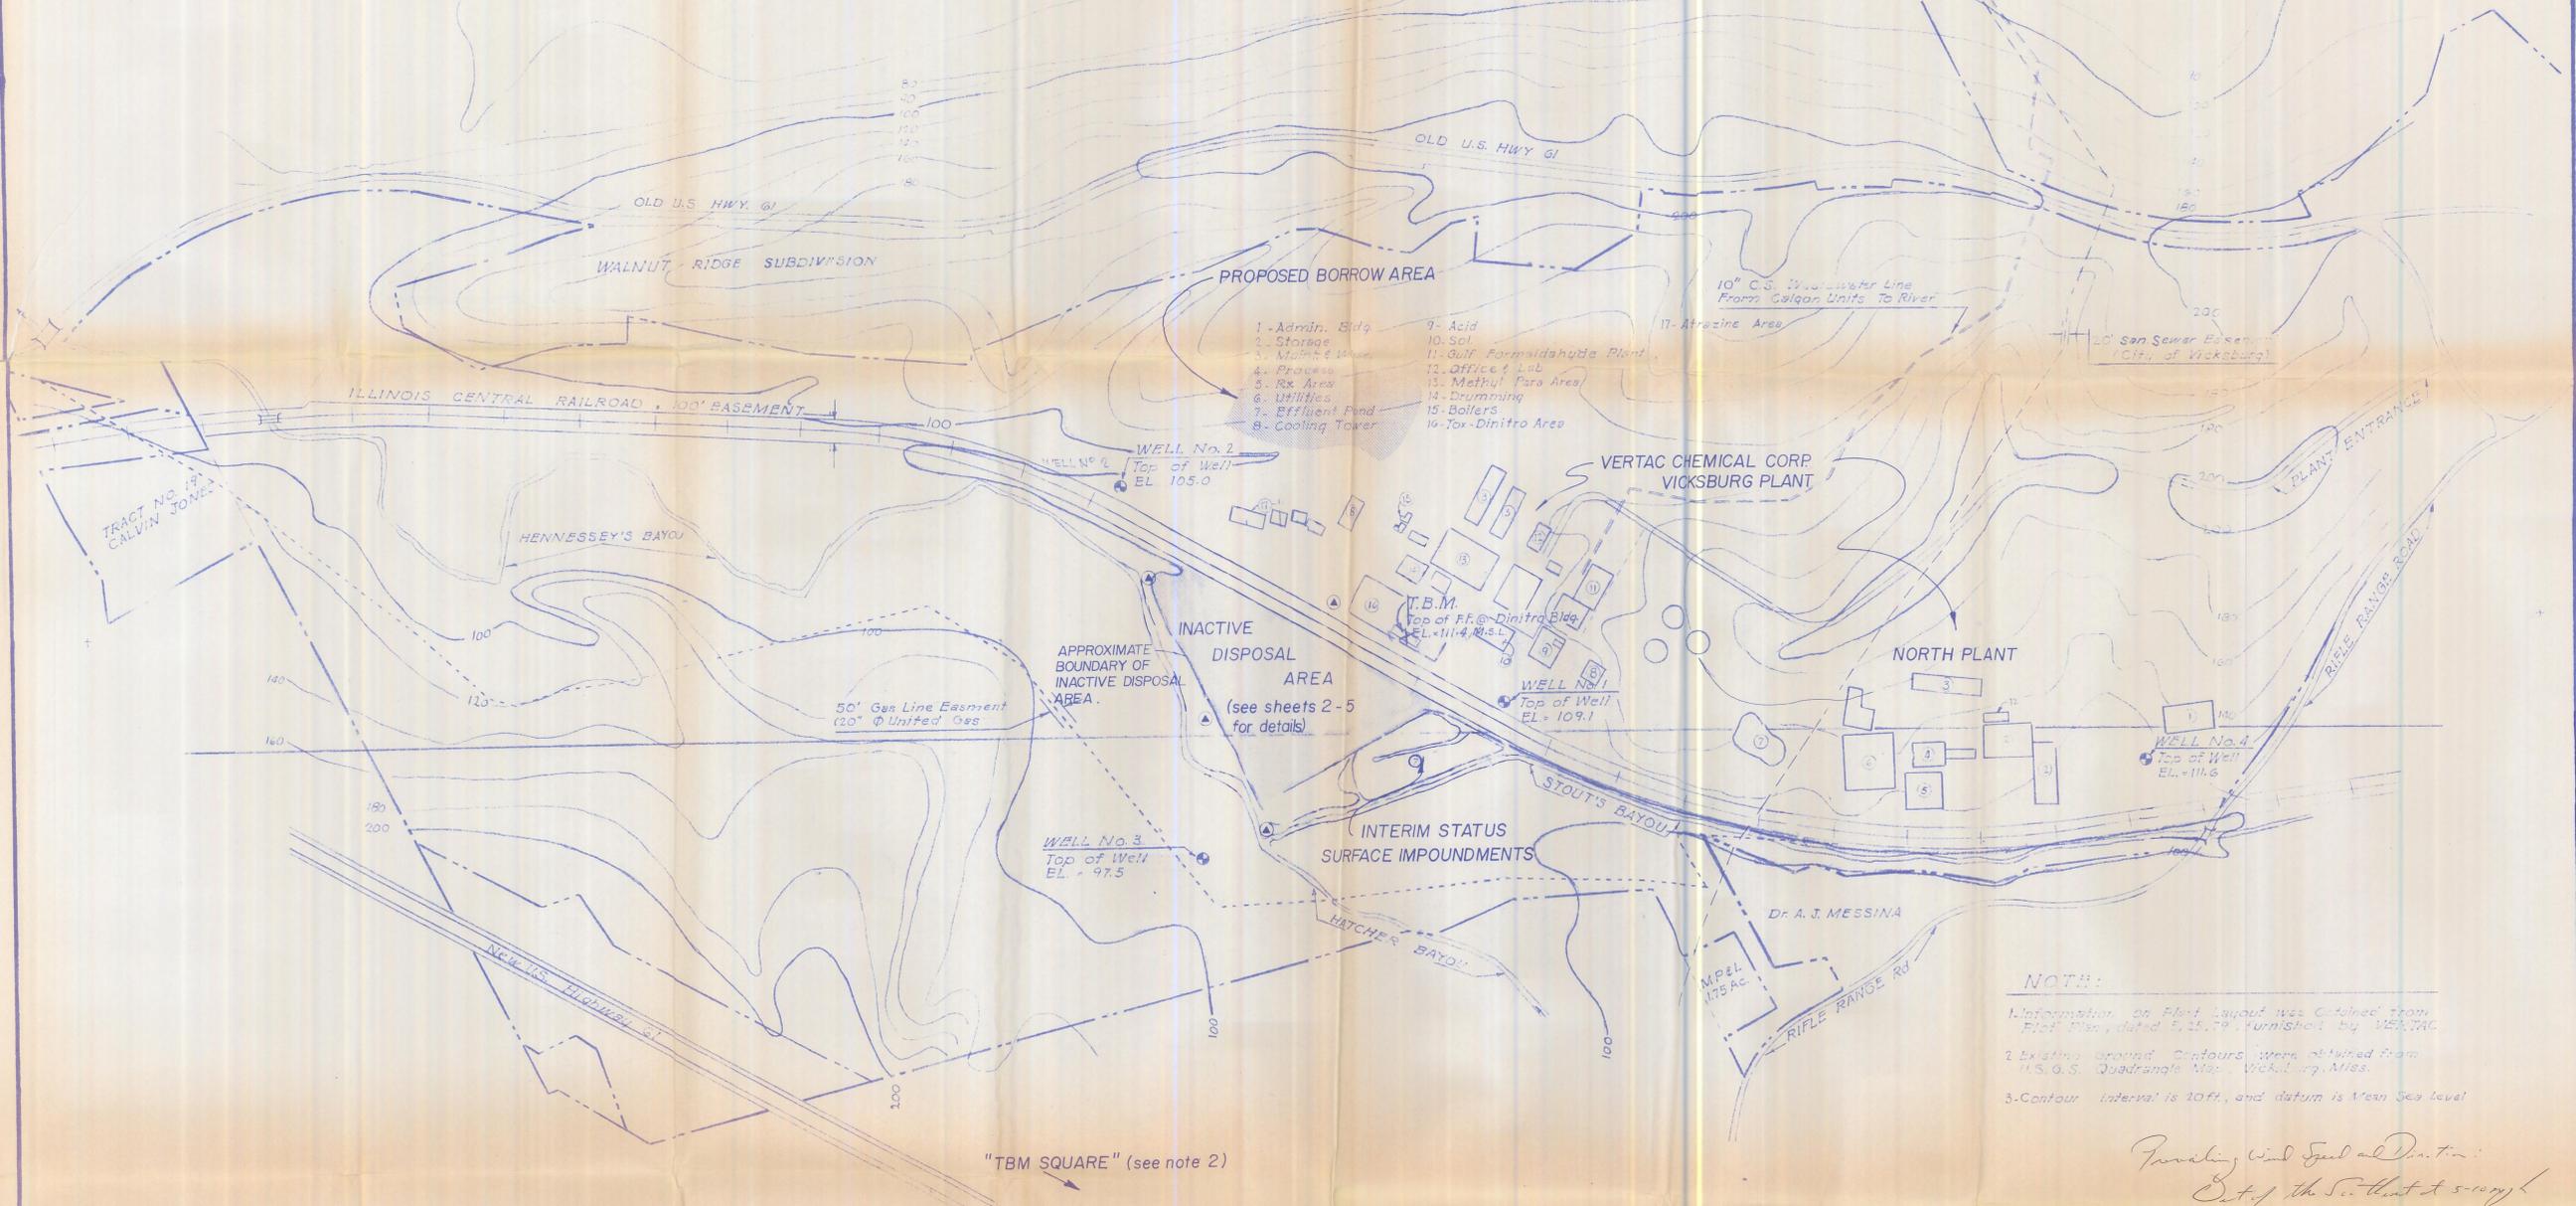
LEGEND  
 Existing ground contours 159  
 Existing ground contours 100

NOTE:  
 1. Information on Plant layout was obtained from Plant Plan, dated 5, 25, 79, furnished by VERTAC.  
 2. Existing ground contours were obtained from U.S.G.S. Quadrangle Map, Vicksburg, Miss.  
 3. Contour interval is 10ft., and datum is Mean Sea Level

*Prevailing Wind Speed and Direction:  
 Out of the Southwest at 5-10 mph*
